SCIREA Journal of Geosciences

Volume 10, Issue 2, April 2026

**GEOLOGICAL AND GEOTECHNICAL
INVESTIGATIONS OF ARTISANAL MINING
SUBSIDENCE AROUND KURU AND GURATOPP
AREAS WITHIN THE JOS PLATEAU TIN FIELDS,
NORTH-CENTRAL NIGERIA**

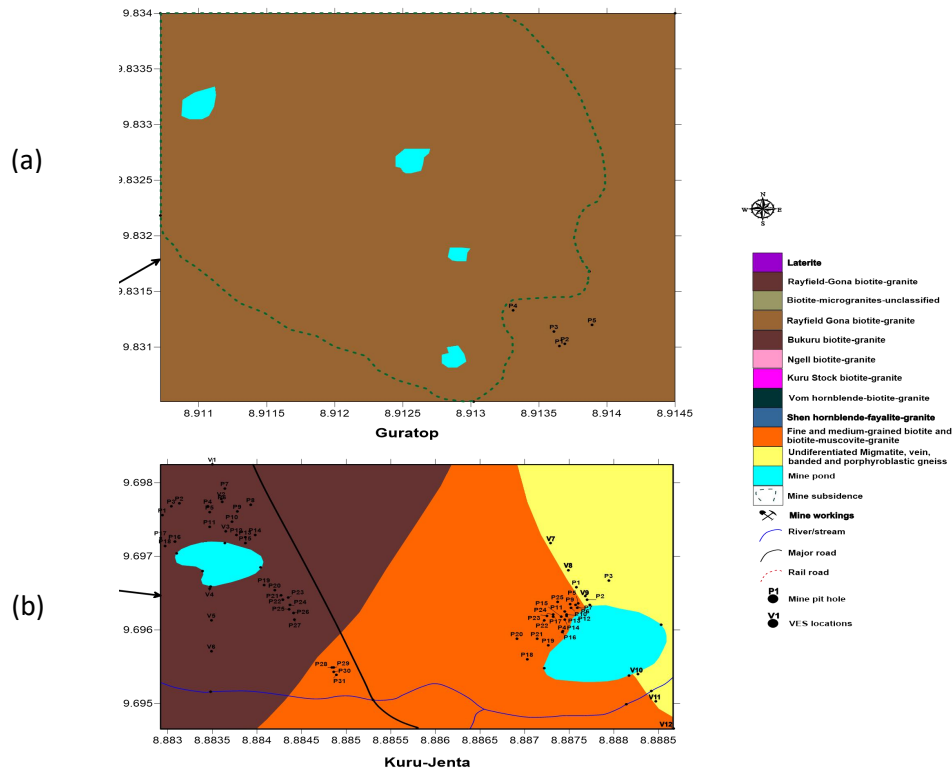
Figure 4. Local Geology of the Guratopp and Kuru-Jenta Artisanal Tin Mining Sites

Kuru-Jenta is underlain by mostly the Bukuru biotite granite, fine medium grained biotite and biotite-muscovite-granite and the undifferentiated migmatite, vein, banded and porphyroblastic gneiss (Figure. 4a) [17]. The Guratopp mining areas are underlain mainly by Rayfield Gona biotite granites (Figure.4b). The study areas are generally low lying with little or no exposure of rock outcrops. The soil cover all characterized thick lateritic core. Rock outcrops of Younger Granite rises instantly and forming the highly trends sometimes in ring forms. The low lying areas are characterized by streams/river/valleys weathering from the Younger Granite which contain casiterite and associated minerals.

There is little or no rock outcrops seen along the Kuru Jenta area except along the NW-SE flowing stream channels. Mine-out pit lithology of Kuru Jenta site I and site II have variable depth of 1 to >10m with a lithological sequence of Top lateritic soils, Clay/Sandy soils, and coarse to gravels/sands. This lithological sequence is similar to the general lithological sequence of the Jos alluvial tin fields [11].

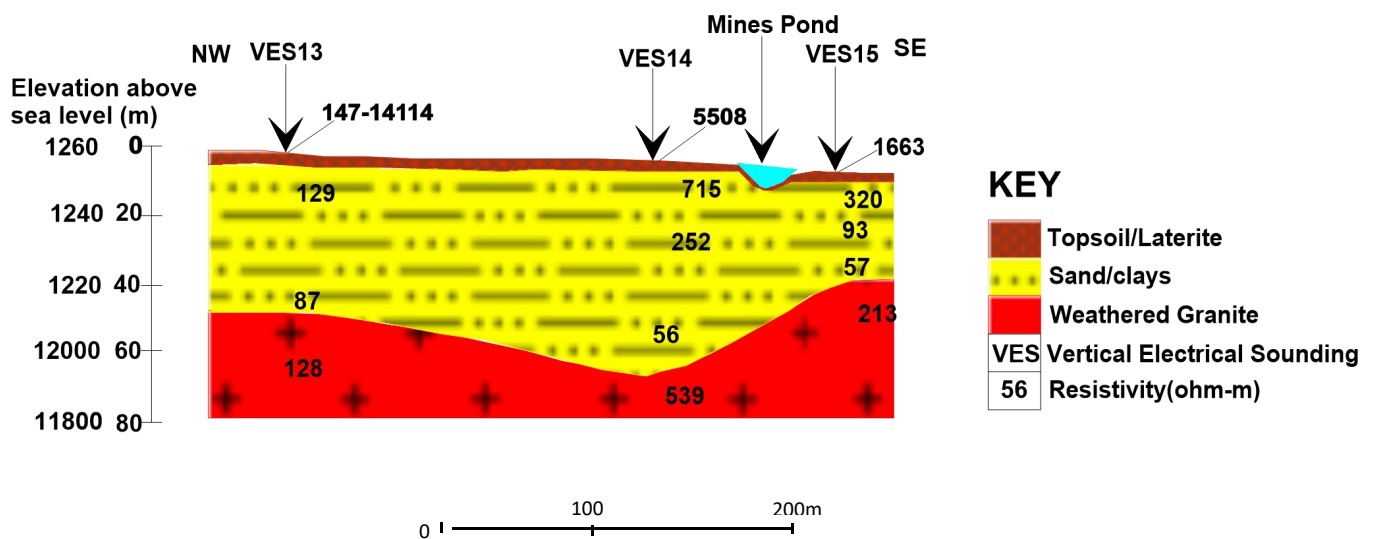
Figure 7. Geo-electric Section: Guratopp Mine Site in Northwest-Southeast Direction

In the Guratopp mining site, the geo-electric section around revealed a similar geo-electric sequence/lithological variation of: Top lateritic soil (0.7 to 7.1m), weathered granite consisting of sands/sandy clays (7 to 27.5m), slightly weathered/fractured granite (>19 to ∞) and characterised by resistivity values of 147 to 14 ohm-mm, 87 to 716 ohm-m and 129 to 539 ohm-m respectively.

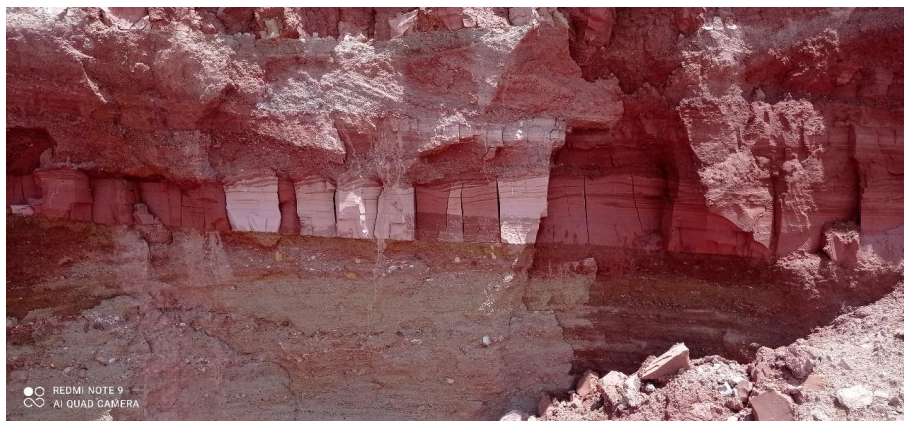
Figure 9. Lithological Section of Mine-out Pit at Guratopp Mine Site.

The Guratopp mine site along the exposed mine (Figure.9) face from top to bottom revealed a slightly different lithological variation with lateritic topsoil, clays with fine grained sands, clays with medium grained sands, fine grained sands, medium grained sands with clays, coarse-gravelly sands at depth of 0 to 0.3m, 0.3 to 1.2m, 1.2 to 2m, 20 to 3.7, 3.7 to 4m and 4 to 5m respectively.

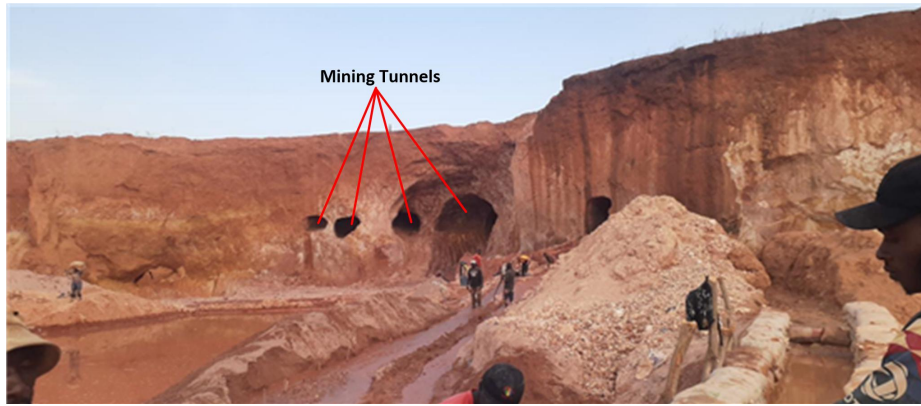
Figure 10. Guratopp Mine Sites Showing the Mining Tunnels

Figure 11 shows the typical artisanal mining by piting and tunneling to access the mineralized tin layers. The multiple or closed clustering of the horizontal tunnels characterized by high groundwater level, most times, generates the mine subsidence. Some of the tunnels go up to 100m or more (Figure. 9 & 10).

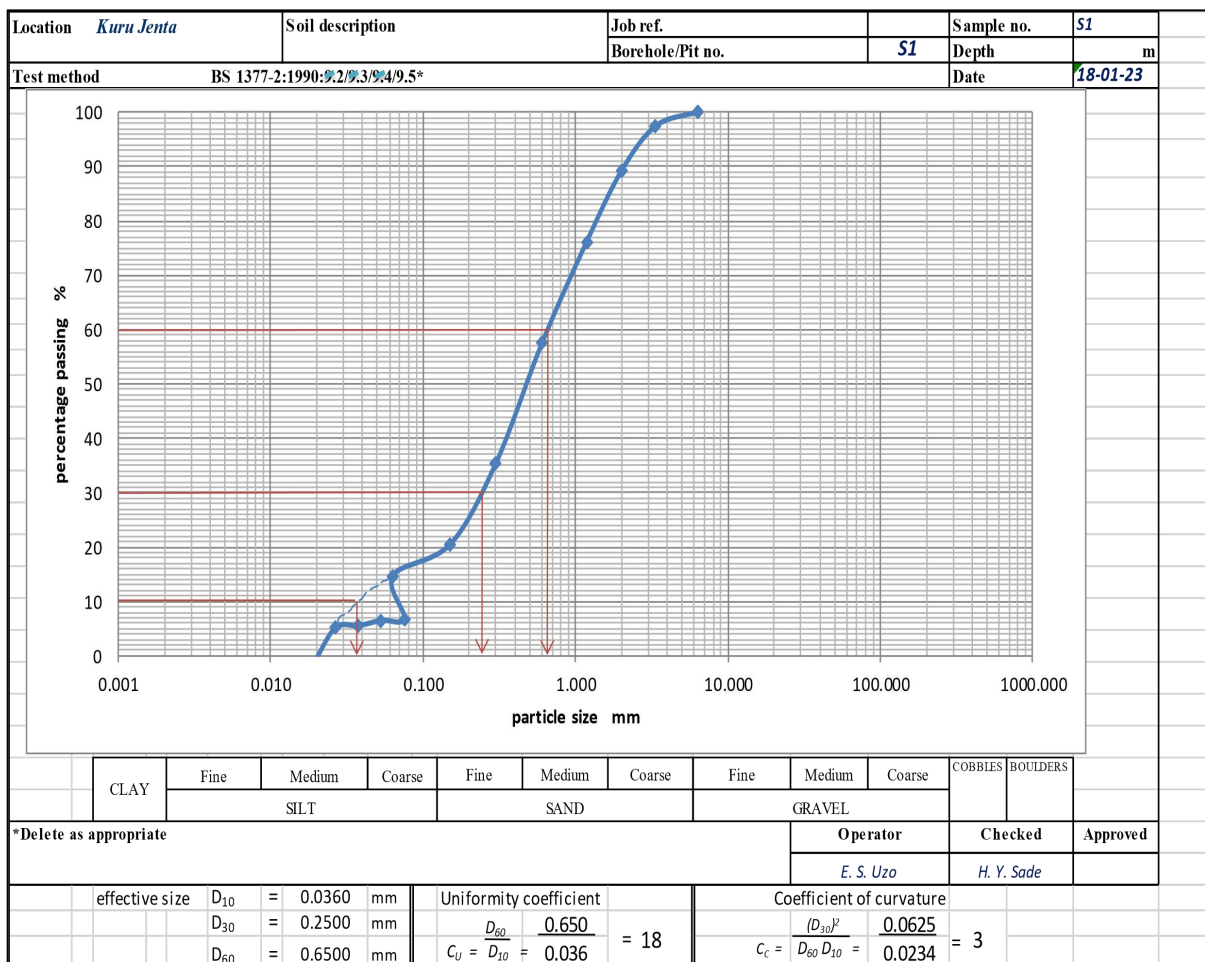
Figure 12. Particle Size Distribution for Kuru Jenta Mining Site

The wet sieve analysis of the Kuru-Jenta Site I and Site II and Guratopp mine sites shows that the particle size distribution ranges from 0.02 to 6.5mm in site I, 0.015 to 10mm site II and 0.015 to 10mm for Guratopp (Figure 3). The calculated coefficient of uniformity C_u , and coefficient of curvature (C_c) for the soils are as shown in Table 3. A well graded soil has adequate contribution of all sizes in a particular soil sample and may be represented by the following combination: Sand – 40%, Silt – 40% and Clay – 20%. However, for the sample for Kuru-Jenta sites I and II and Guratopp, the distribution of soil sizes are poor and gap graded (Table 4).

The Kuru-Jenta samples had coefficient of curvature of zero ($C_c=0$) while coefficient of uniformity $C_u=12, 21$, while that for Guratopp: $C_u=0, C_u=6$.

A well graded soil has C_c values as $\{1 < C_c < 3\}$. Any value less than 1 or more than 3 is gap graded or poorly graded ($C_c < 1$ or > 3) [28, 31]. Soil density of gap graded soil is low and porous allowing seepage with less compaction and density [28, 31]. For Guratopp samples, $C_c=0, C_u=6$. A $C_c > 6$ for sand and $C_u > 4$ for gravels indicate the soil sample has a wide range of
